**SUBJECT: 2nd Quarter 2018 NOA Monitoring Report
Rock Hill Quarry Operation
SMP No. 7974SM1
East Rockhill Township, Bucks County
EarthRes Project No. 061003.051**

FIGURE 1
SAMPLE LOCATION MAP

ROCK HILL QUARRY
HANSON AGGREGATES PENNSYLVANIA, LLC
EAST ROCKHILL TOWNSHIP
BUCKS COUNTY, PENNSYLVANIA

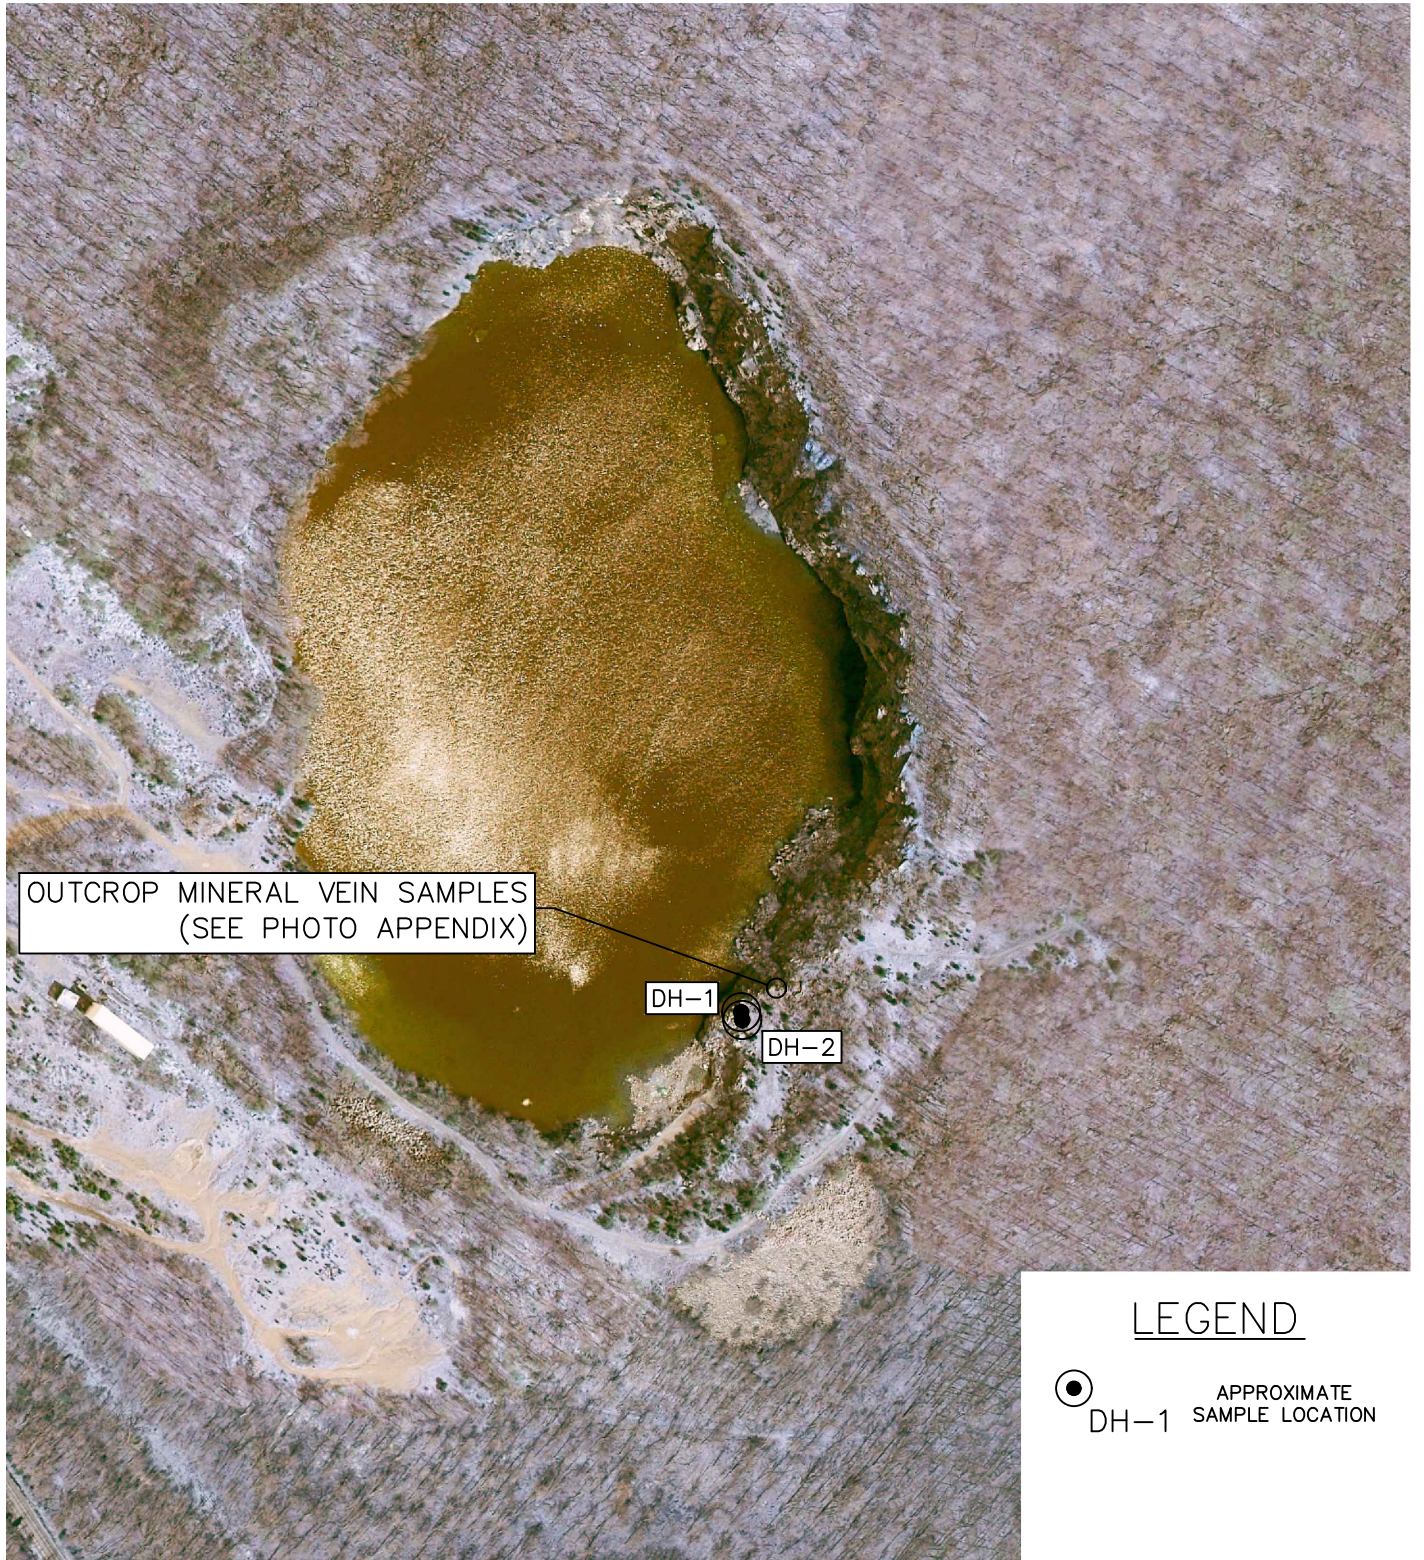
FIGURE 1

from two (2) drill holes on the active bench. The corresponding sampling locations are shown on the attached Figure in Appendix A. The composite samples were collected using a sterile plastic scoop that was used to mix and collect the drill cuttings. One (1)-gallon Ziplock® bags were filled with approximately 0.5 gallons of drill cuttings from each borehole. The two drill cutting samples were then combined into a single one-gallon Ziplock® bag evenly and mixed.

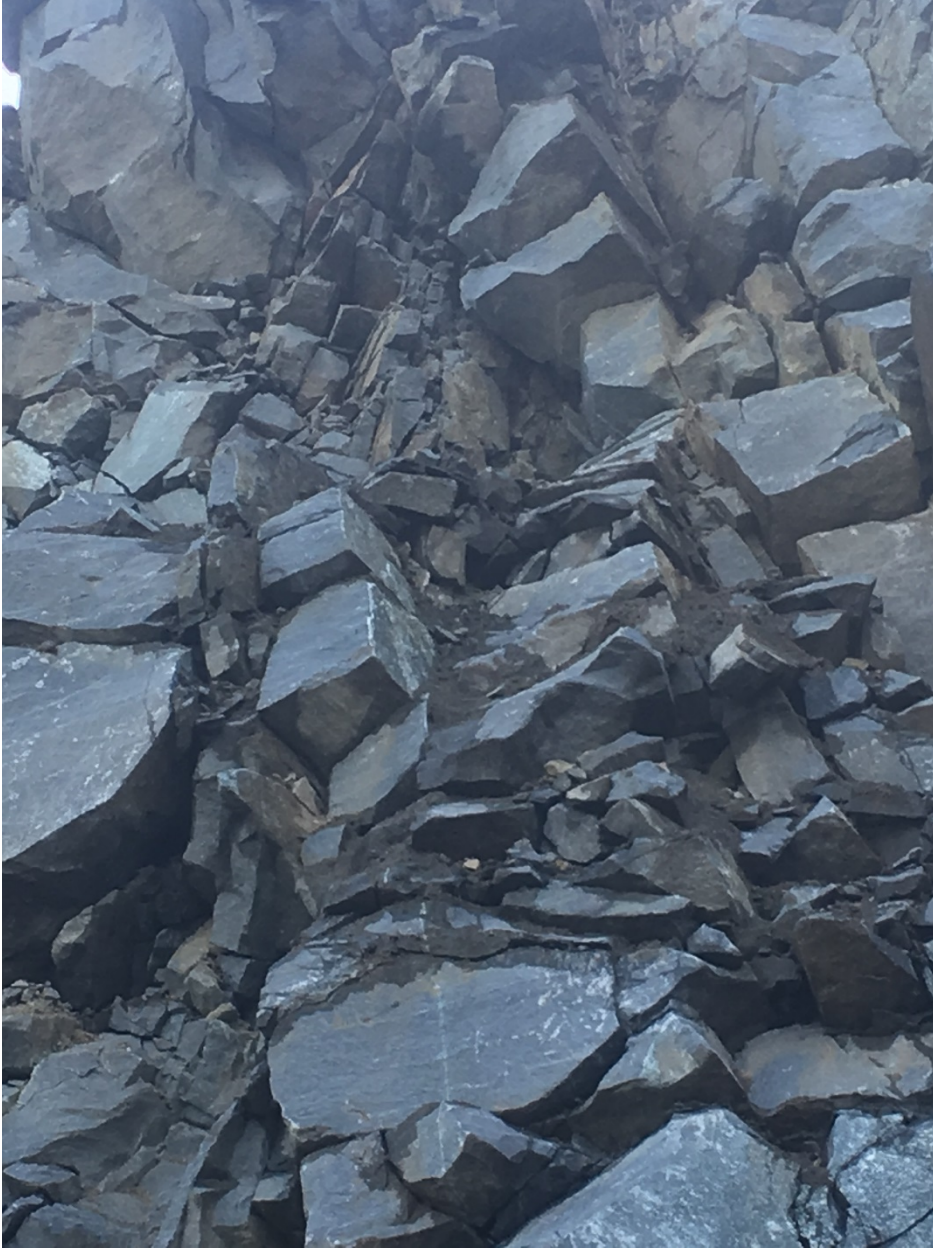
An outcrop hand sample of observed mineral veining from the bench face was collected while onsite. The hand sample was compared to previously collected samples, and was found to be similar and from the same location that was sampled and reported as non-detect for NOA in our report of January 18, 2018. The sample location is shown on the attached Figure in Appendix A. Pictures of the highwall, specific sampling locations and the collected sample are provided on the photographs in Appendix B.

Photo 1: Vein exposed in active face.

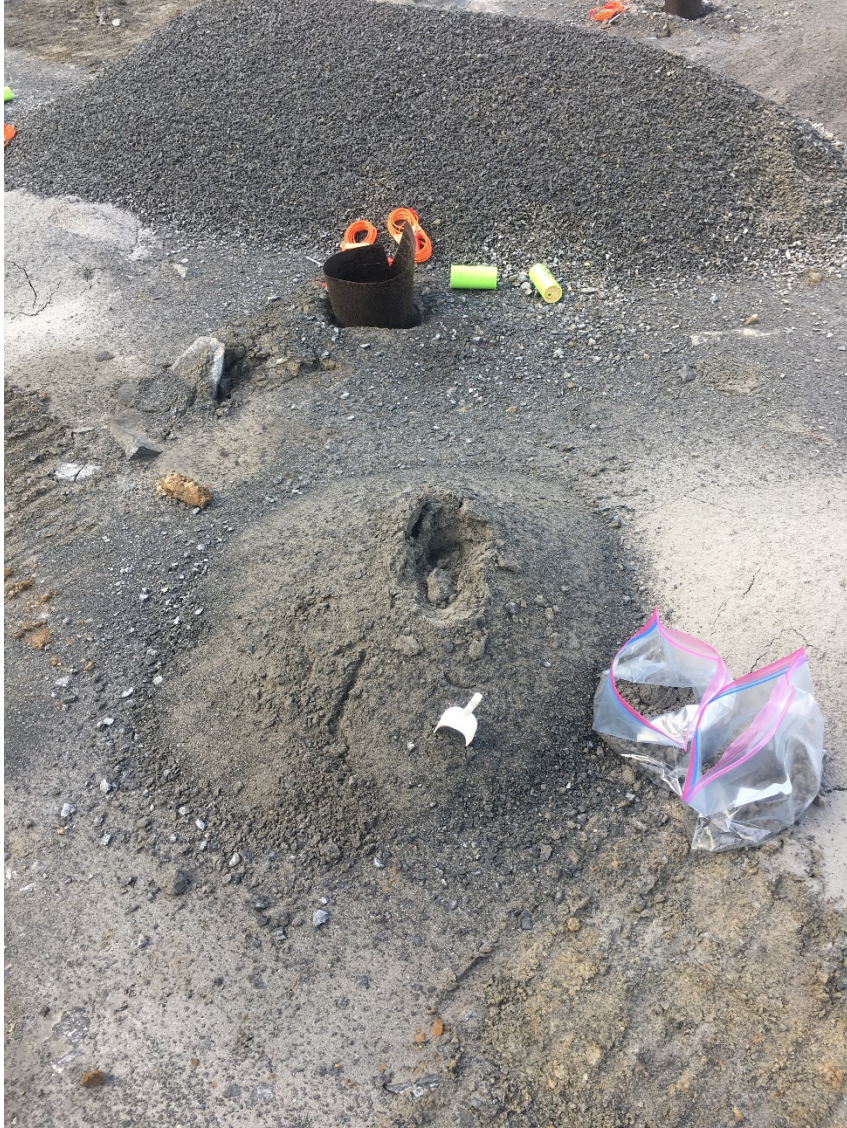
Photo 2: DH-1 drill cuttings and sample location.

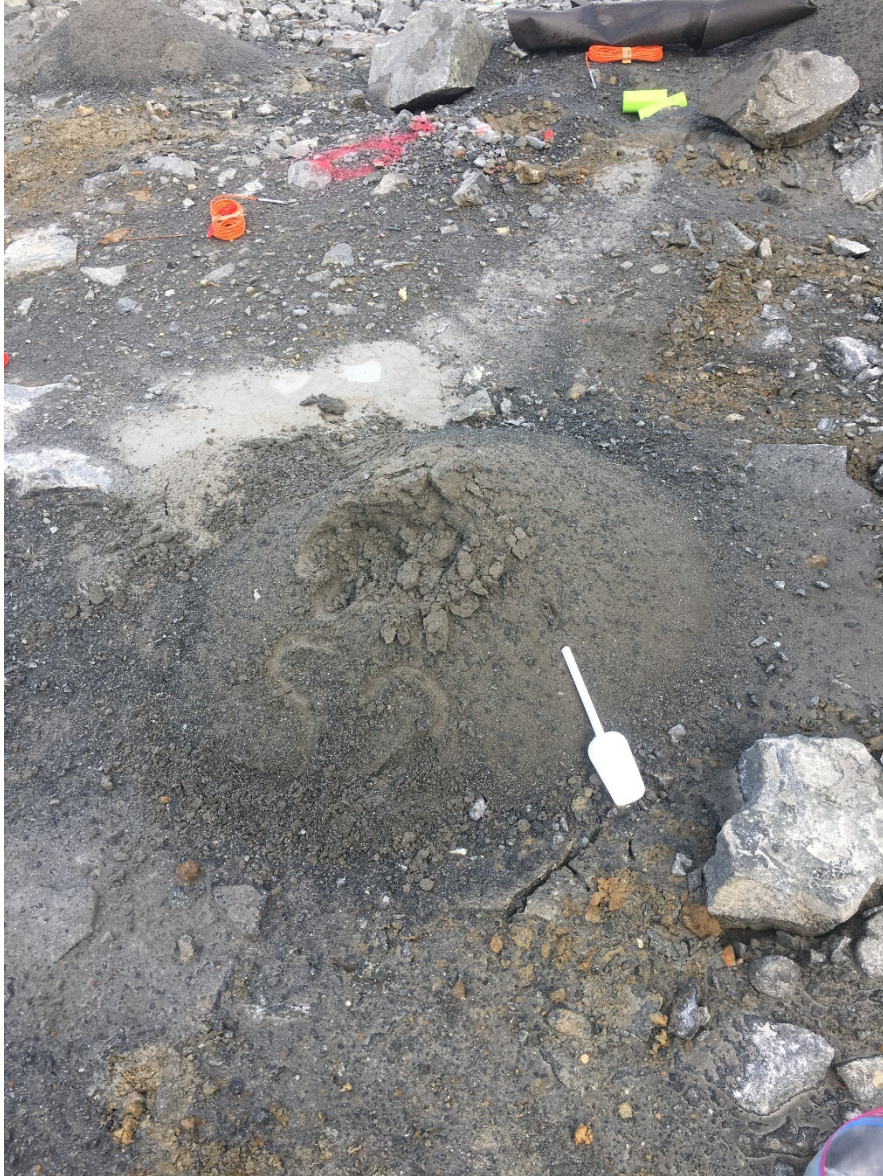
Photo 3: DH-2 drill cuttings and sample location.
